BLUE BIRD

S16YN

Subject: S16YN
Rear Air Disc Brake Axle Shaft Flange Nut Replacement

Models Affected: Model Year: Certain 2015-2017
Model: Vision and All American
School Bus and Non-School Bus

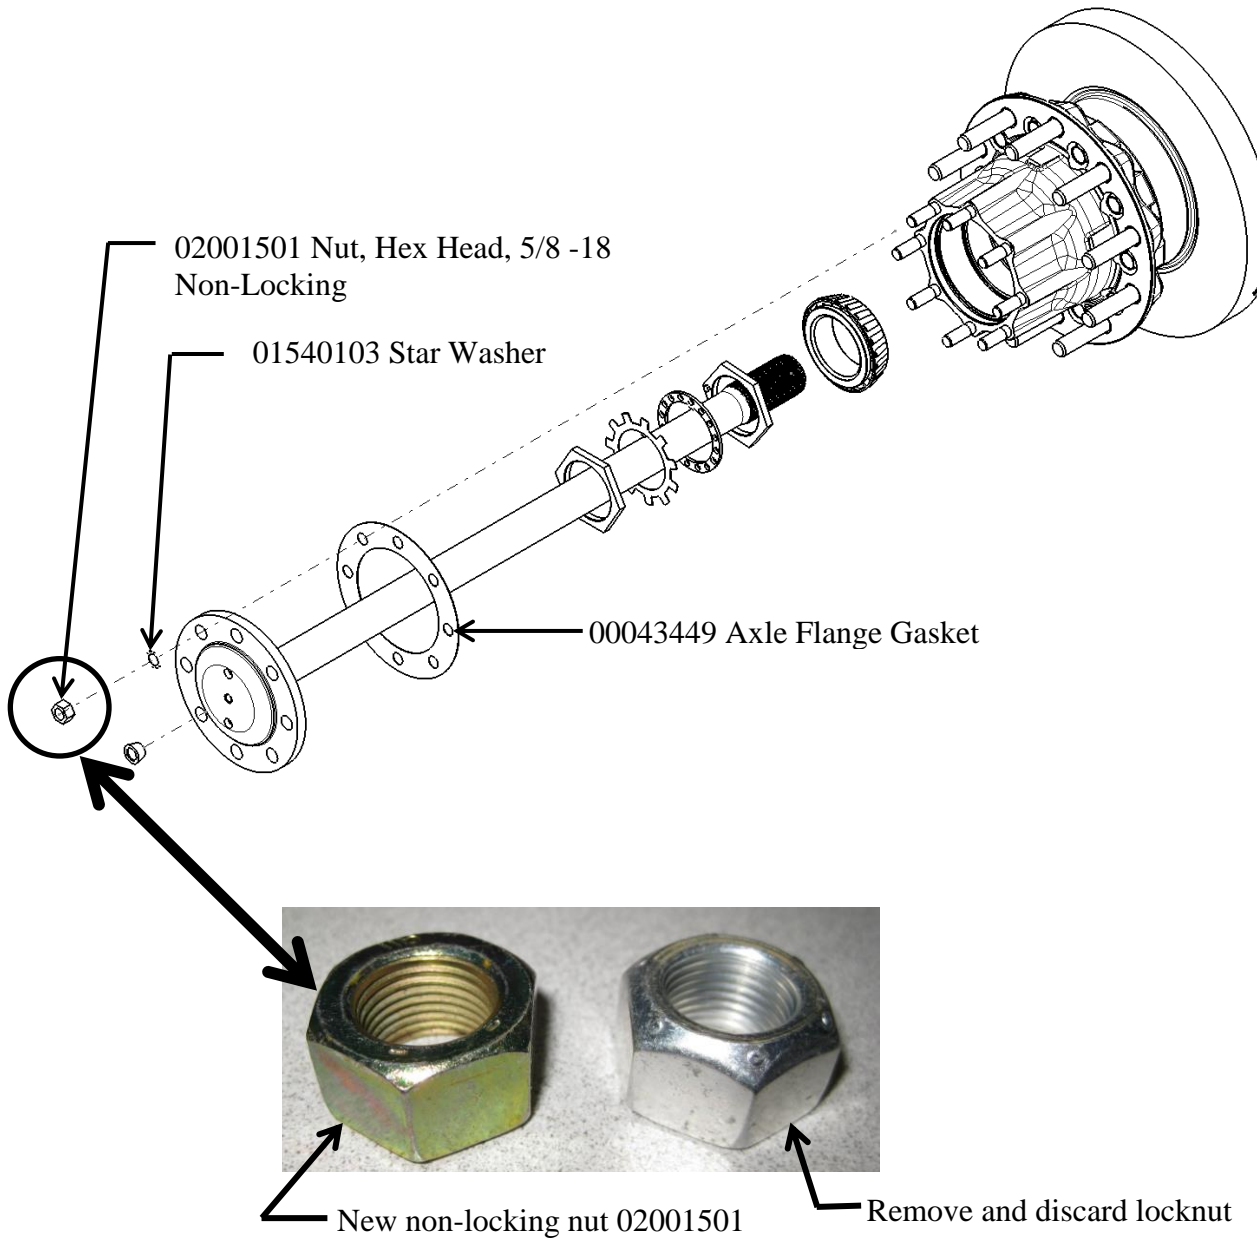
REAR AIR DISC BRAKE

Rear axle shaft flange nut torque reduces allowing for oil leak between the axle shaft and hub.

Replace the existing rear axle flange lock nut with a new non-locking nut and star washer. Request that the Service Manual be updated by technician to show new nut and torque.

1. Park bus on level surface, turn off engine, remove ignition key, and chock wheels.
2. To reduce the possibility of the stud being removed when removing locknut, remove the paint from the existing rear axle shaft flange studs.
3. Remove and discard the first lock nut and star washer.
4. Replace the hardware in Step 3 with a new star washer 01540103 and a new non locking nut 02001501.
5. Torque nut to 60-70 ft-lb.
6. If a stud comes out during removal of locknut, remove the locknut from the stud and reinstall the stud into the hub. Torque stud to 60 to 70 ft-lb.
7. Remove the next lock nut and star washer in a “star” pattern.
8. Repeat Steps 3 to 6 until all eight star washers and lock nuts are replaced.
9. Re-torque all nuts to 170-180 ft-lb. in a “star” pattern.

NOTE 1: If there is a leak at the rear axle flange gasket, remove and discard all eight locknuts and star washers. Replace gasket, install axle shaft, and install eight new star washers 01540103 and new non-locking nuts 02001501. Torque all eight nuts per Step 9 above.
