BLUE BIRD

Subject: S16YU, Rear Air Disc Brake Axle Shaft Flange Gasket Replacement
S16YU Replaces S16YN

Rear Air Disc Brake Axle Shaft Flange Gasket Replacement

S16YU REPLACES S16YN

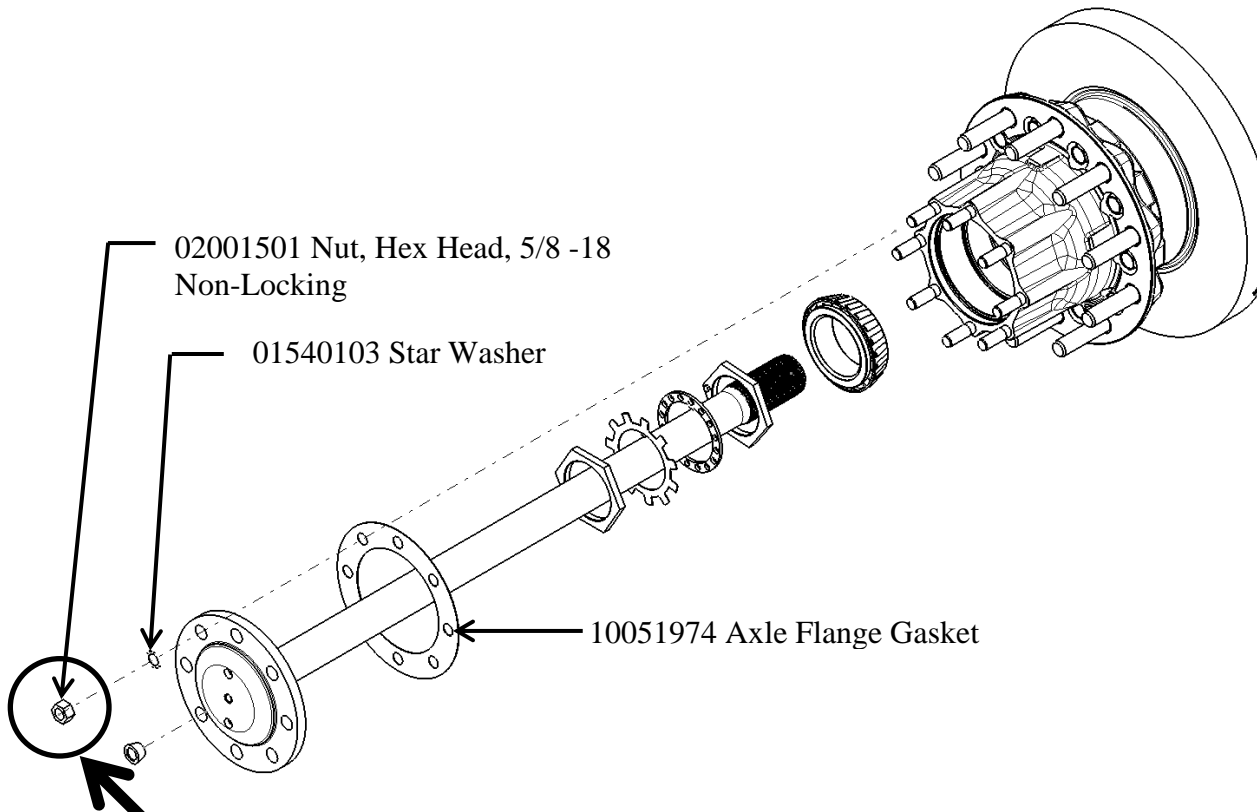
REAR AIR DISC BRAKE

Rear axle shaft flange gasket torque relaxes allowing for possible oil leak between the axle shaft and hub.

Replace the existing rear axle flange gasket with a new gasket and with new star washers. If the original locking nut has not been replaced with a new non-locking nut, replace locking nuts with non-locking nuts.

1. Park bus on level surface, turn off engine, remove ignition key, and chock wheels.
2. To reduce the possibility of the stud being removed when removing nuts with paint, remove the paint from the existing rear axle shaft flange studs.
3. Remove all (8) eight nuts and star washers on both sides. Replace existing axle flange gasket with new 10051974 gasket on both sides and install axle shaft. If a stud comes out during removal of nut, remove the nut from the stud and reinstall the stud into the hub. Torque stud to 60 to 70 ft-lb.
4. If the bus has the original locknuts, replace with new non-locking nuts. Install eight (8) new star washers 01540103 and eight (8) non-locking nuts 02001501 (removed from axle studs) on both sides.
5. Torque nuts to 60-70 ft-lb.
6. Re-torque all nuts to 170-180 ft-lb. in a “star” pattern.
