Subject: Service Bulletin S14XA Inspect Transmission Harness Routing and Cooling Hose Connections

Models Affected: 2013-2015 Model Year Vision (BBCV) Models Equipped with Ford Propane Engines

BBCV Ford Transmission Inspect Harness Routing – Oil Cooler Hose Connection

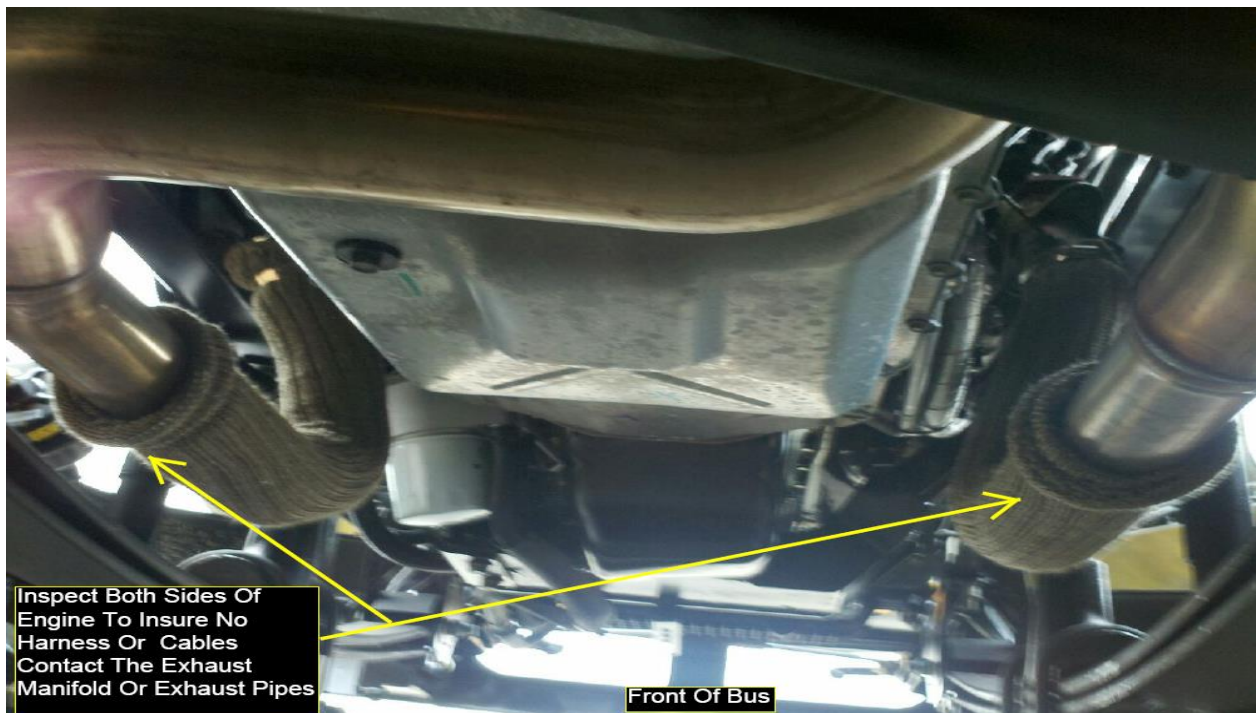
1. Park bus on level surface, apply parking brake, turn off ignition and remove key.
2. Chock wheels
3. Caution, engine, transmission, and exhaust manifold **MUST be at ambient** temperature before proceeding.
4. Inspect transmission harness routing to insure no contact with exhaust manifold or exhaust pipes. Note: Check both sides of engine. See photos and illustration of correct harness routing.
5. If required, reroute and secure harness as shown to prevent contact with engine exhaust manifold or exhaust pipes.

Transmission harness may not be properly routed and secured. Transmission oil cooler hose may not be properly connected.

Inspect and, if required, relocate and secure transmission harness. Check for proper connection and installation of transmission oil cooler hoses to transmission cooler and transmission tube assembly.

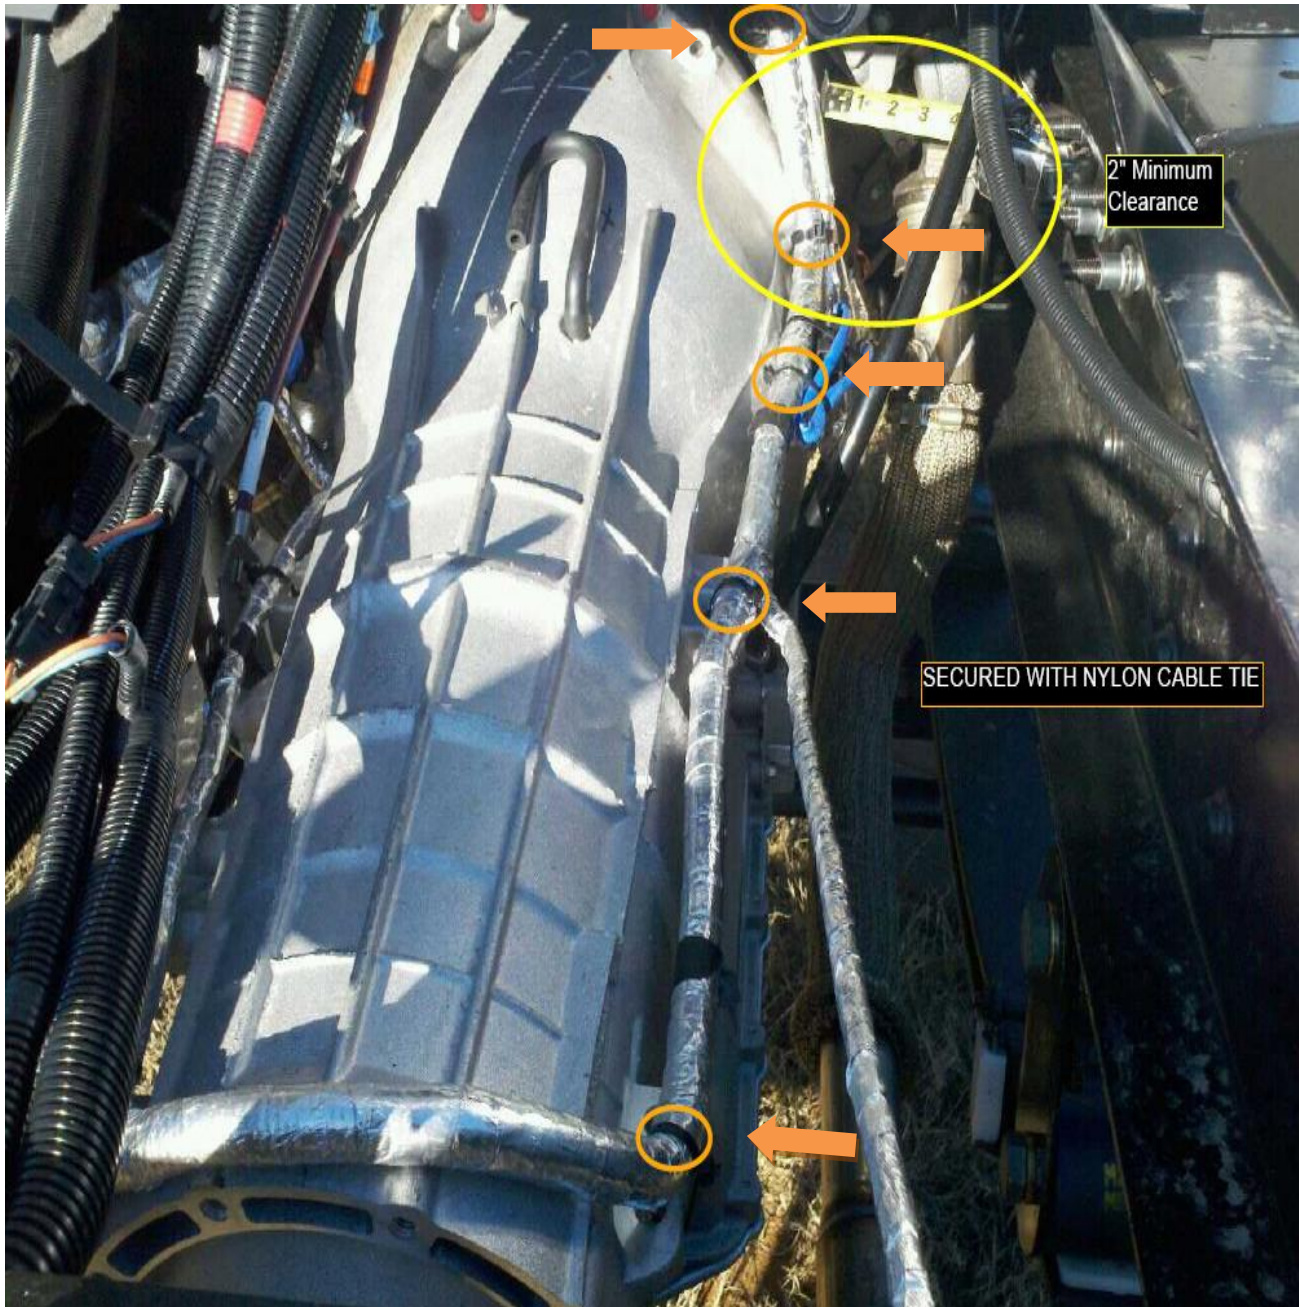
Note: Insure harness is routed and secured to maintain a minimum 2" clearance away from exhaust. See circled areas of photo below.

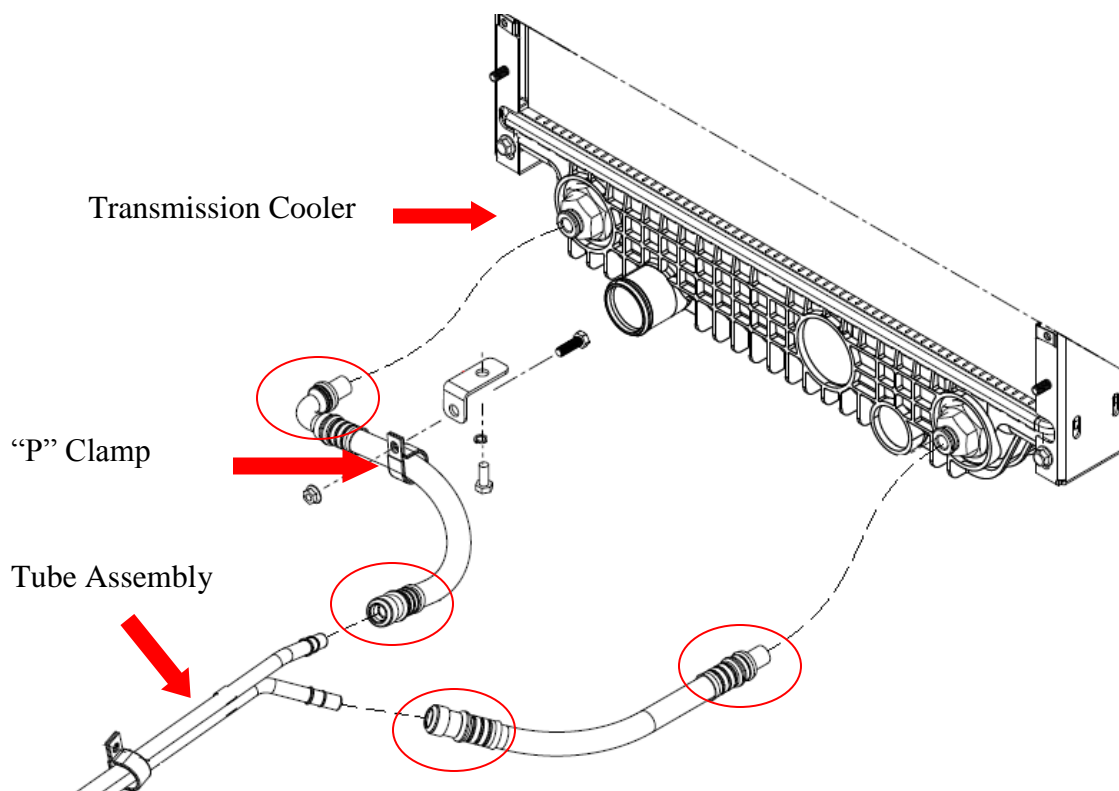
Figure 1

1. Check for proper connection of each transmission hose where they connect to the transmission cooler and tube assembly (see circled connections in figure 1). Refer to page 5 for verification procedure on “push to connect” hoses.
2. Check for proper orientation of “P” clamp securing the transmission hose to the bottom of the radiator shroud. If clamp is not oriented per figure 1, remove clamp and re-install as shown in figure 1 below.
3. Check transmission fluid level per instructions in the Service Manual.
4. Remove wheel chocks.
5. Place bus back into service.

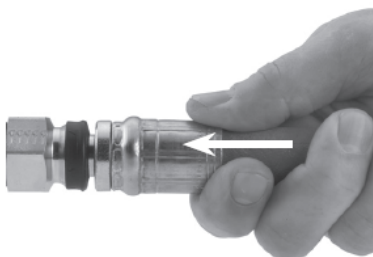
Correct Method

Align the STC fitting on the hose assembly with the STC connector. Push the hose fitting into the mating connector until you feel a definite snap and a solid stop.

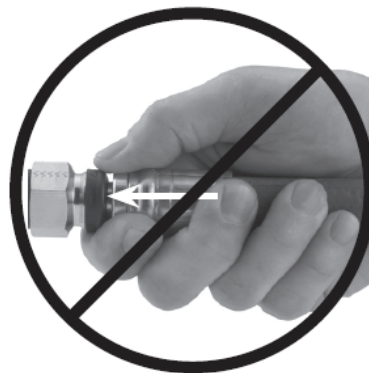
Incorrect Method

Do not hold sleeve during assembly

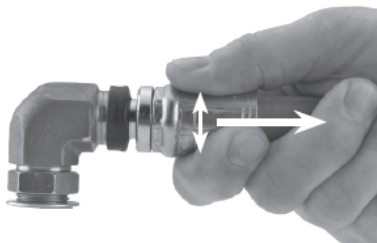
Correct Method

Verify that the STC connection has been made successfully by pulling on the connection to make sure that the male connector has been properly inserted into female connector. Be sure that the direction of pull is parallel to the axis of the STC connection.

Pulling parallel to the connections axis

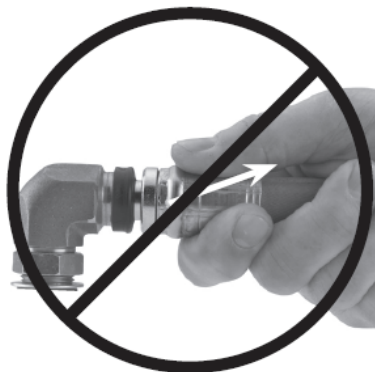
Incorrect Method

Pulling at an angle to connections axis

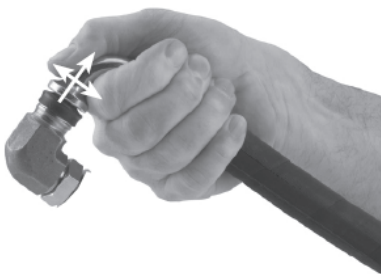
Correct Method

Pulling on the fitting such that the motion is parallel to the connections axis.

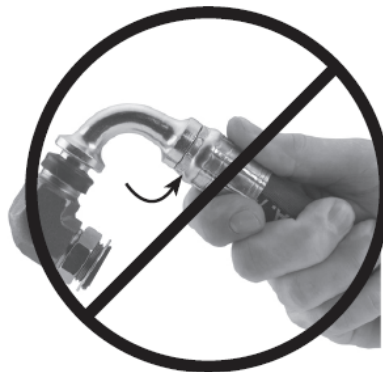
Incorrect Method

Subjecting the connection to a sideload by pulling on the hose.
