**Subject:** Service Bulletin S14XT Heater Motor Circuit Update

**Models Affected:** 2000-2011 Model Year All American Model Buses  
2004-2010 Model Year Vision Model Buses  
2004-2008 Model Year Conventional Model Buses

***Blue Bird Service Bulletin S14XT  
All American Model  
Front Heater/Defroster Jumper  
Installation Instructions***

# Rear Wall Heater Motor Fused Circuit Protection

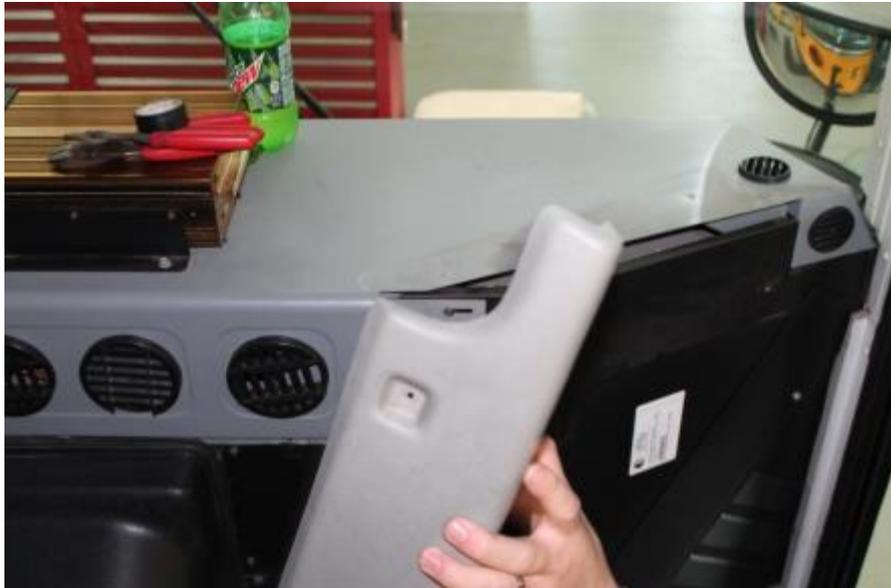
- Remove trim around the heater unit

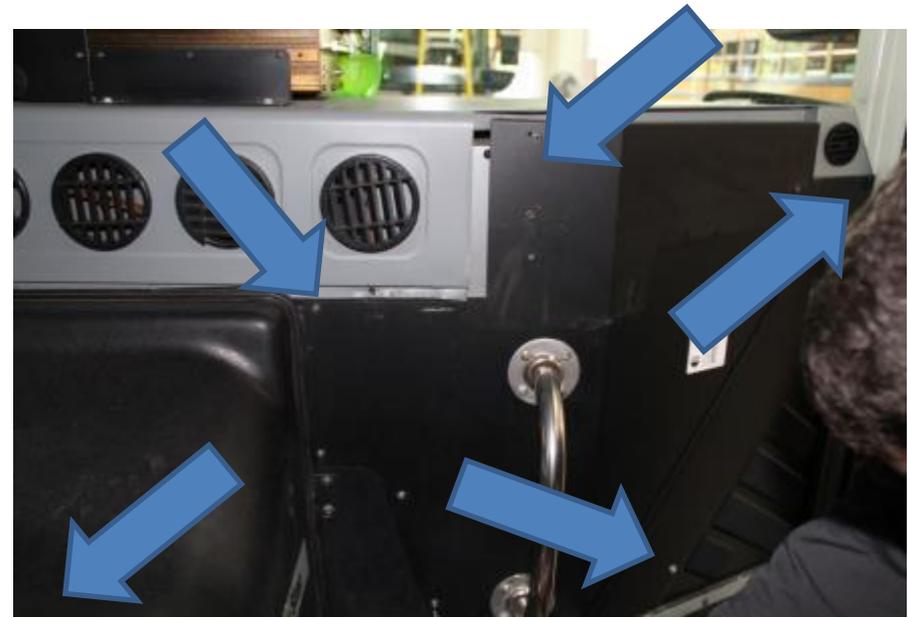
- Remove screws from heater cover panel & remove panel

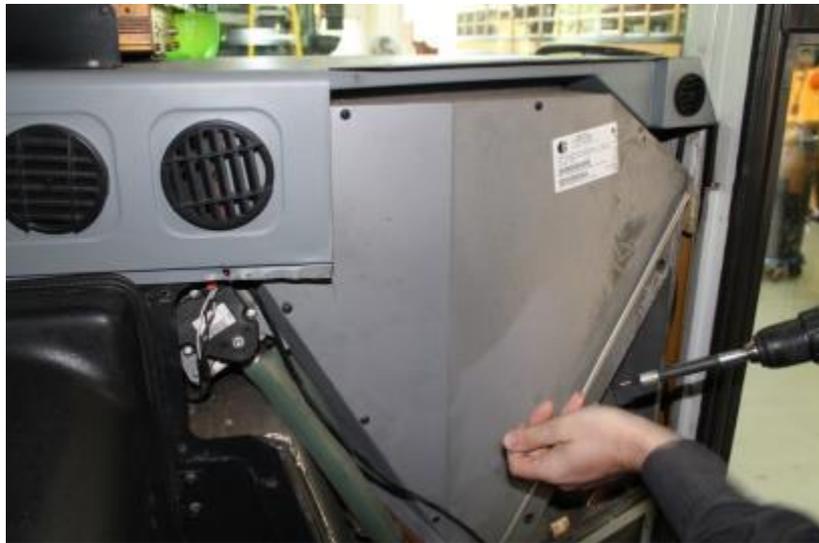
- Remove screws from heater panel

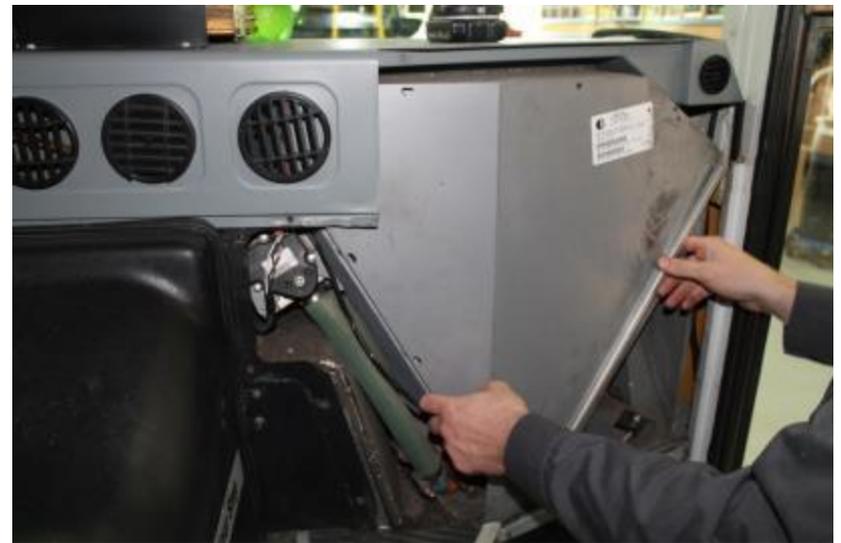
- Remove heater panel

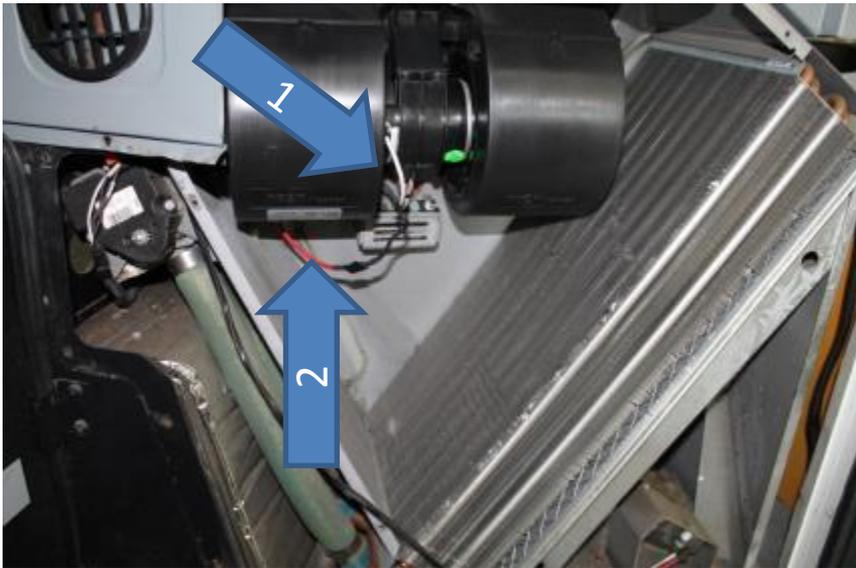
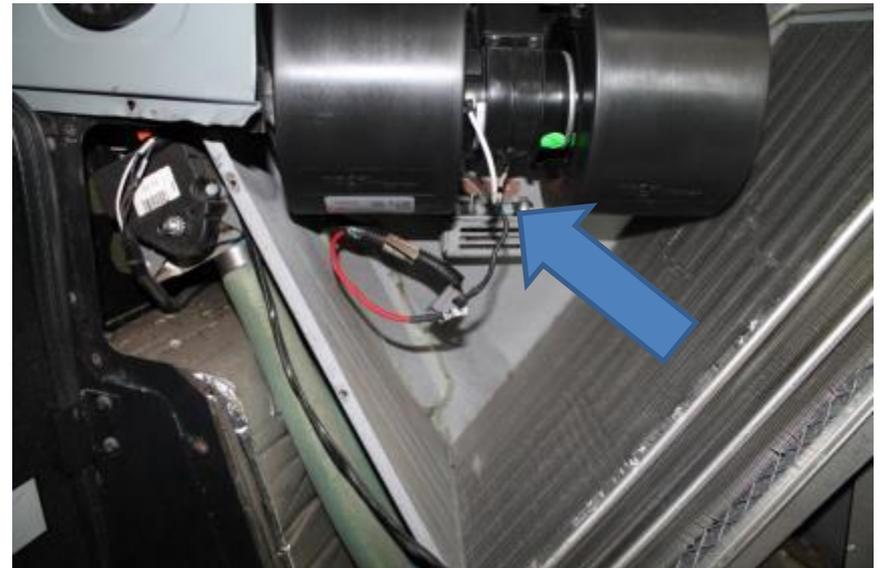
1. Gain access to blower motor connector
2. Disconnect Red wire

- Remove connector from resistor block

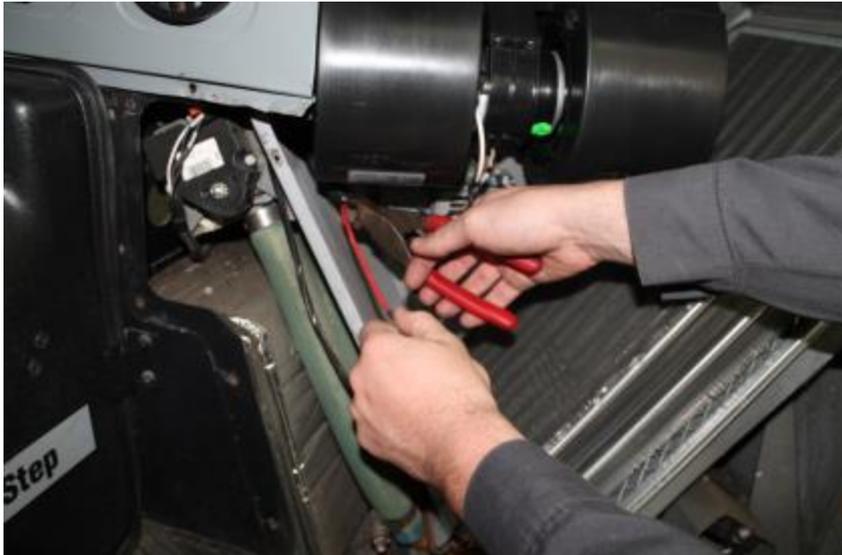
- Cut Red Wire from blower motor

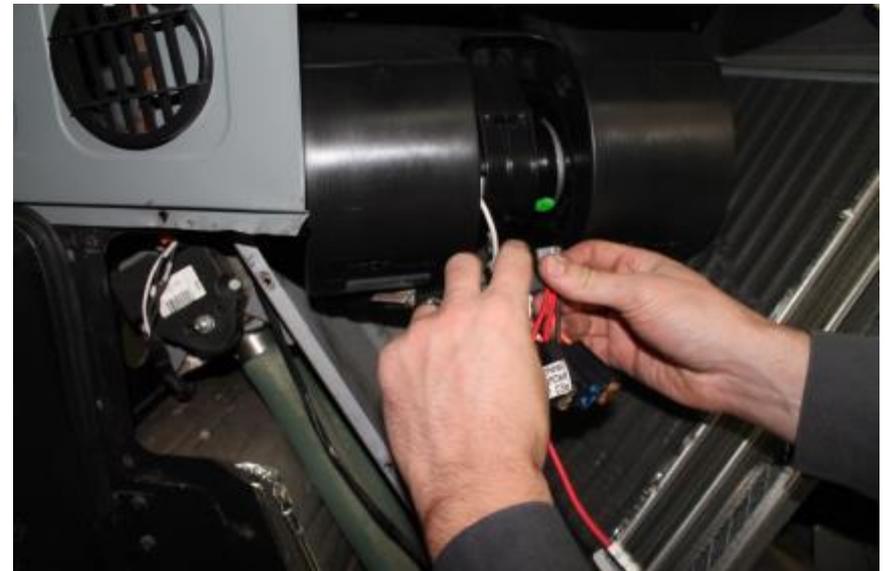
- Tape wire back into the harness with electrical tape

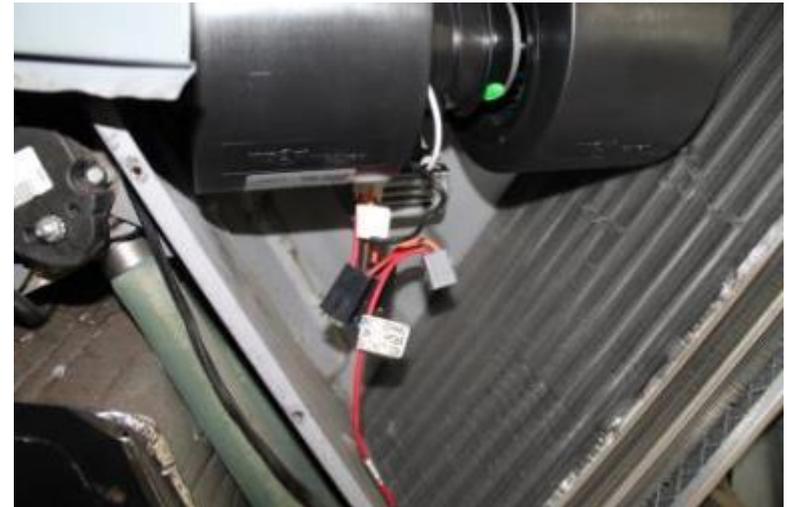
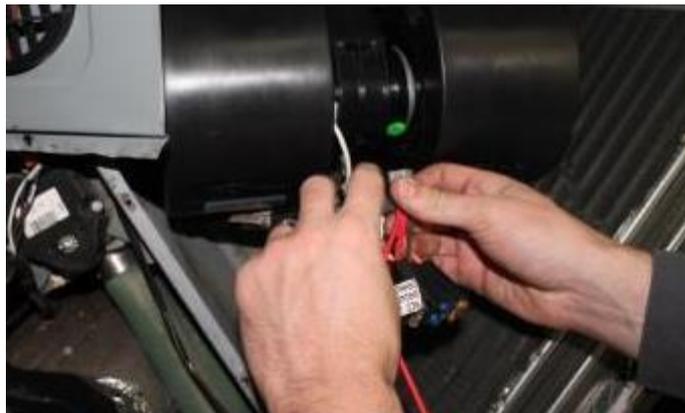
- Connect jumper harness to resistor block

- Connect jumper harness wiring harness

Use Bergstrom part #1000785177 for the following part numbers.

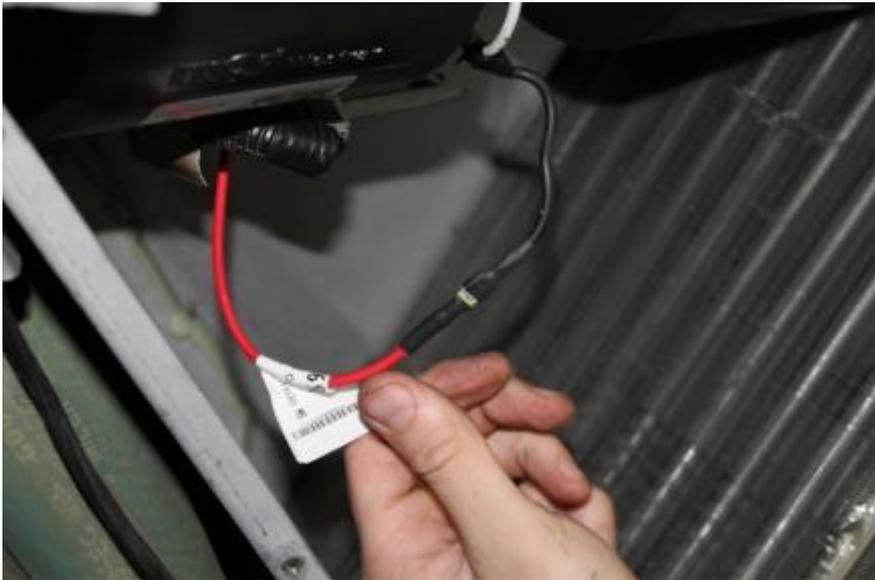
- Connect red wire from jumper harness to black wire

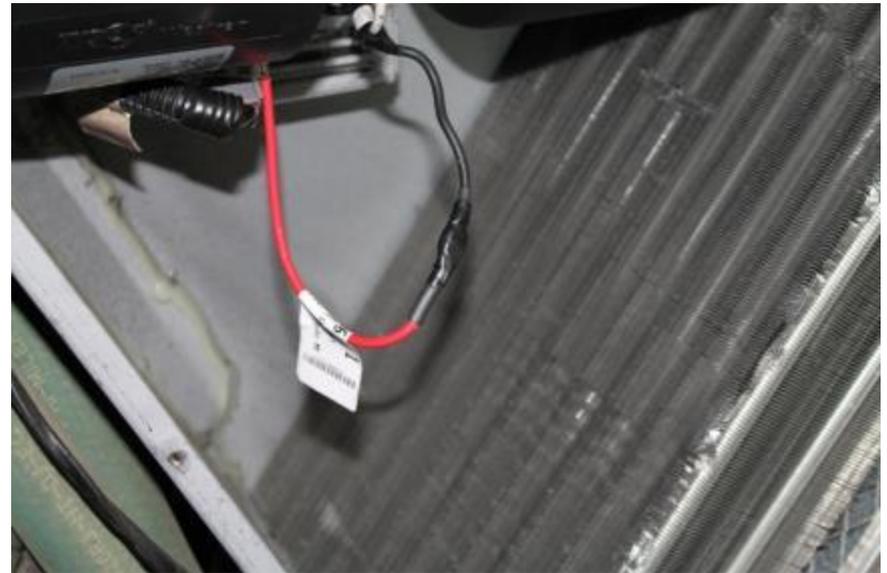
- Tape the connection using electrical tape

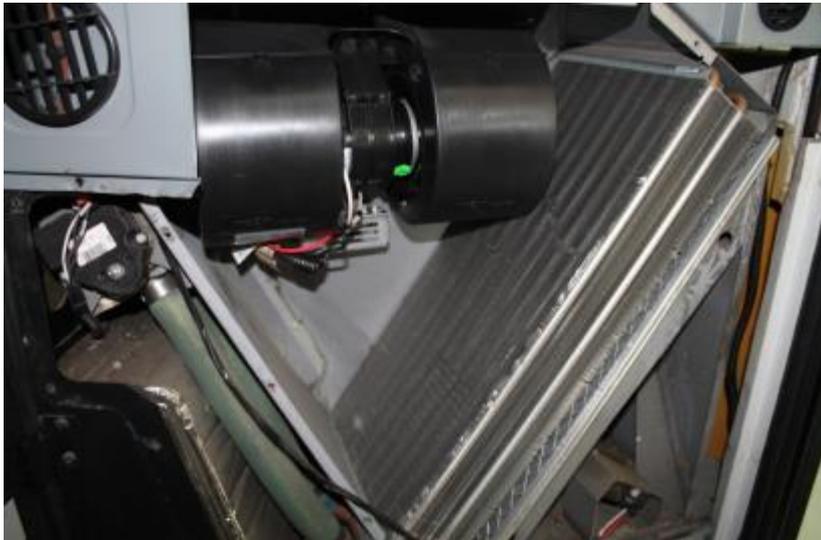
- Secure wires behind motor assembly

- Run heater for 3 minutes on each speed
- If any fuses open, replace the blower motor
- If motor performs on each speed, reassemble the heater parts

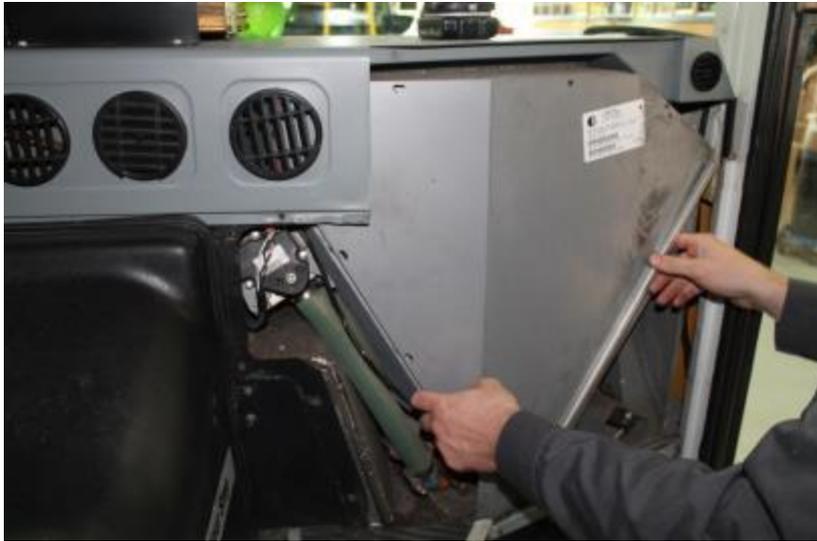
- Install heater panel

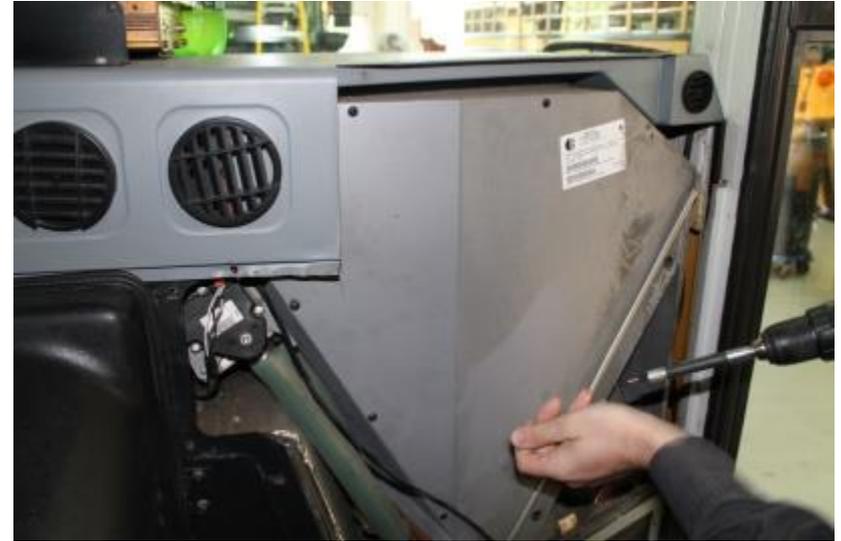
- Install screws for heater panel

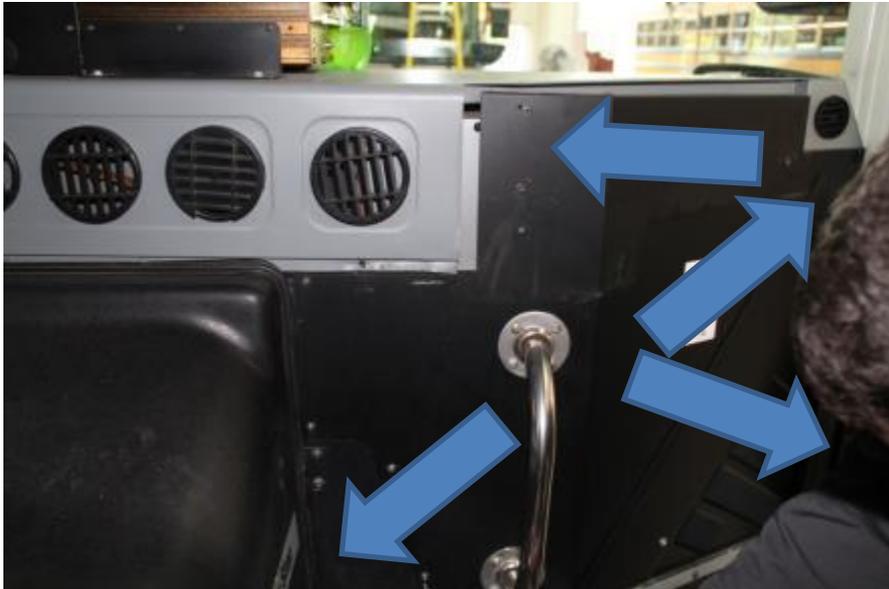
- Install heater cover panel & install panel screws

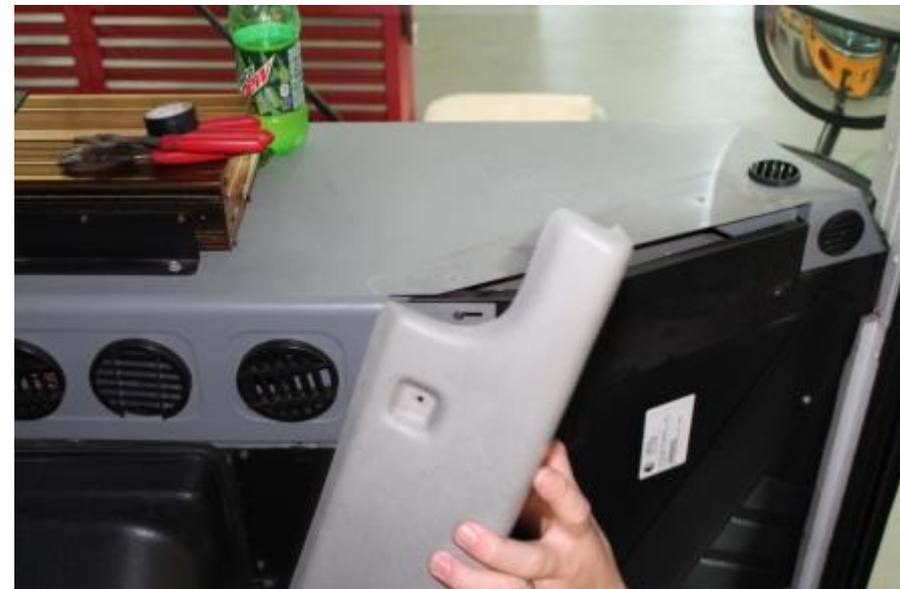
- Install trim around the heater unit

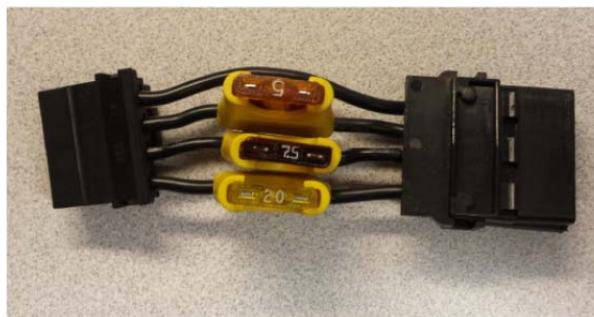
Jumper Harness

1. Before performing service bulletin, verify all rear wall heater blower motor speeds operate correctly and repair if necessary.
2. Park the bus on a level surface, apply parking brakes, turn off engine and remove ignition key. Chock wheels
3. Identify quantity of rear wall heater motors on bus affected by service bulletin.
4. One (1) rear wall heater jumper harness (Part Number: 1000662031) is required for each rear wall heater motor.

Add jumper harness (Part Number: 1000662031) with individual circuit fuse protection for both low and high speed circuits of each rear wall heater blower motor.

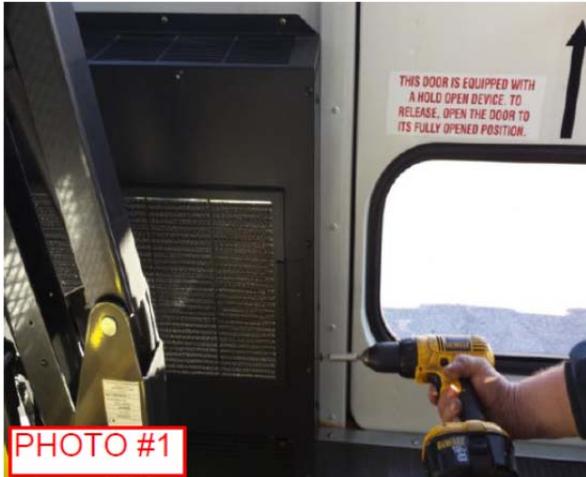
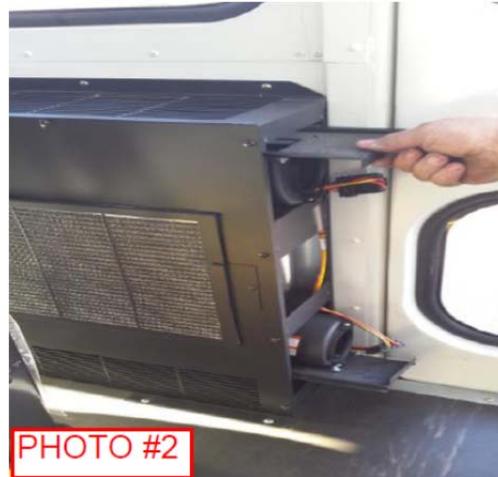
5. Remove ten (10) Phillips screws and end cover from rear wall heater. Slide blower motor assemblies out to access the four pin connector on each motor.  
(See photo 1 & 2)

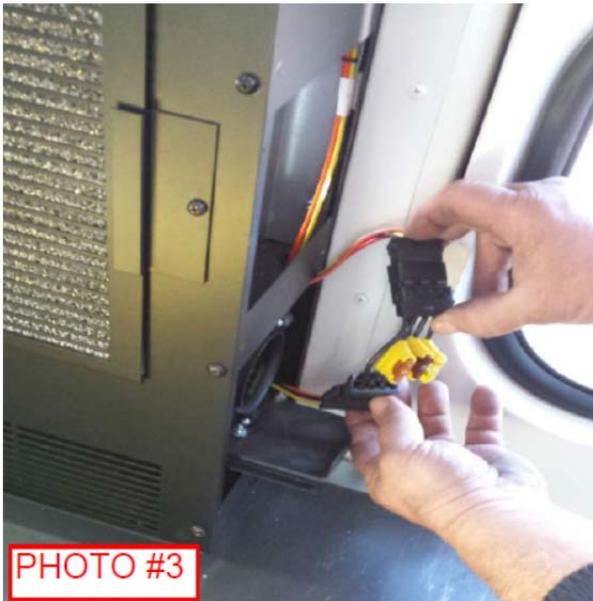
6. Unplug one rear wall heater motor connector at a time and install jumper harness in series.  
(See photo 3) Repeat this step for each rear wall heater motor harness.

7. Slide blower motor assemblies back in and install end cover with ten (10) Phillips screws.
8. After jumper harness installation, verify both low and high rear wall heater blower speeds operate.
9. If either blower speed fails to operate verify jumper harness fuse is installed, not blown (open). Contact your Blue Bird dealer if you require any assistance.

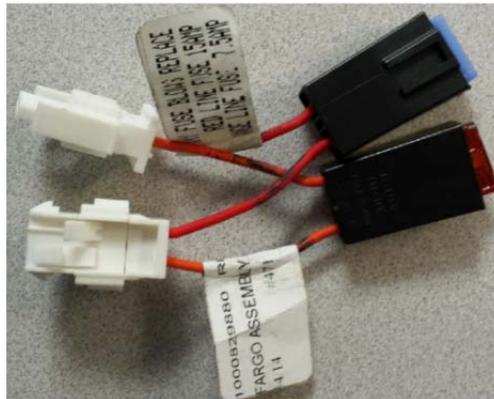
Jumper Harness

1. Before performing service bulletin, verify all under seat heater blower motor speeds operate correctly and repair if necessary.
2. Park the bus on a level surface, apply parking brakes, turn off engine and remove ignition key. Chock wheels
3. Identify quantity of under seat heater motors on bus affected by service bulletin.
4. One (1) under seat heater jumper harness (Part Number: 1000829880) is required for each under seat heater motor.

Add individual circuit fuse protection (Part Number: 1000829880) for both low and high speed circuits of each under seat heater blower motor.

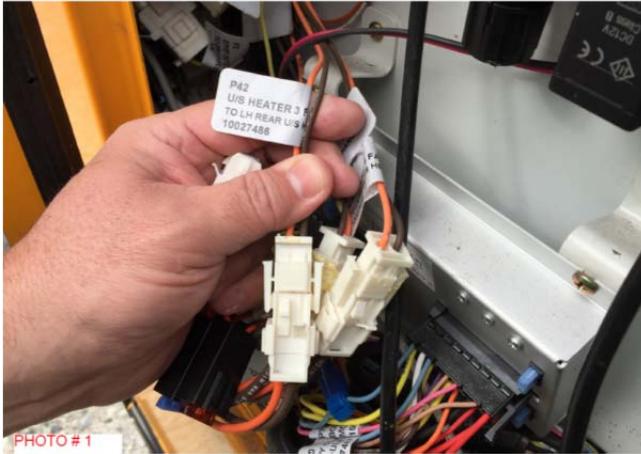
5. Open the body electrical panel access door located directly below the driver side window. Each under seat motor has a two pin harness connector located in the lower left corner. (See photo #1)

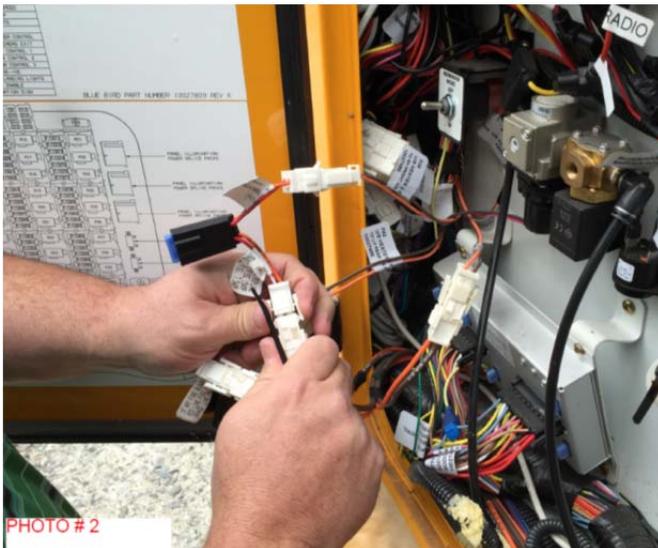
6. Unplug one under seat heater motor harness connector at a time and install jumper harness in series. (See photo #2) Repeat this step for each under seat heater motor harness.

7. After jumper harness installation verify both low and high under seat heater blower speeds operate.
8. If either blower speed fails to operate verify jumper harness fuse is installed, not blown (open). Contact your Blue Bird dealer if you require any assistance.

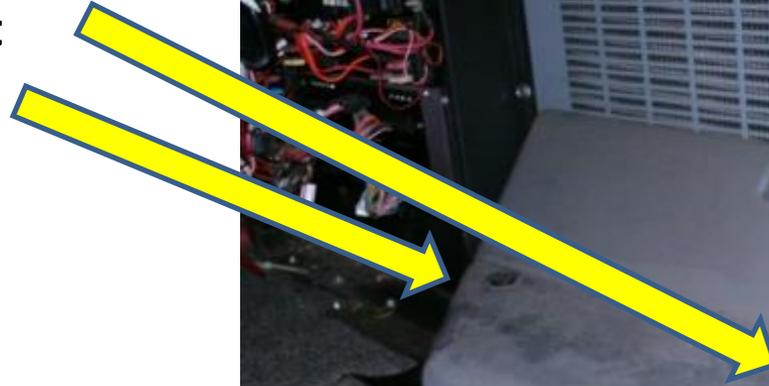
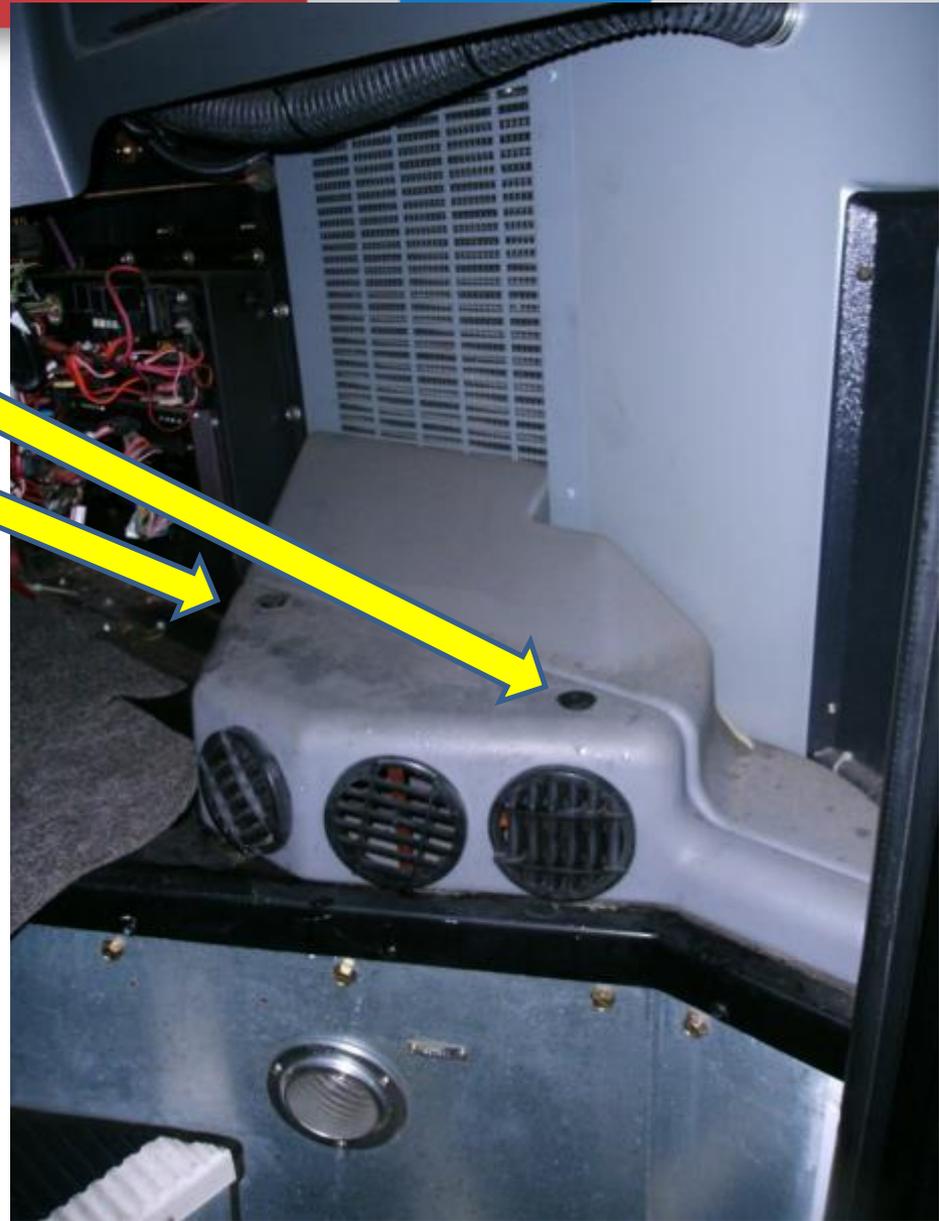
Remove the plastic plugs on the top of the unit

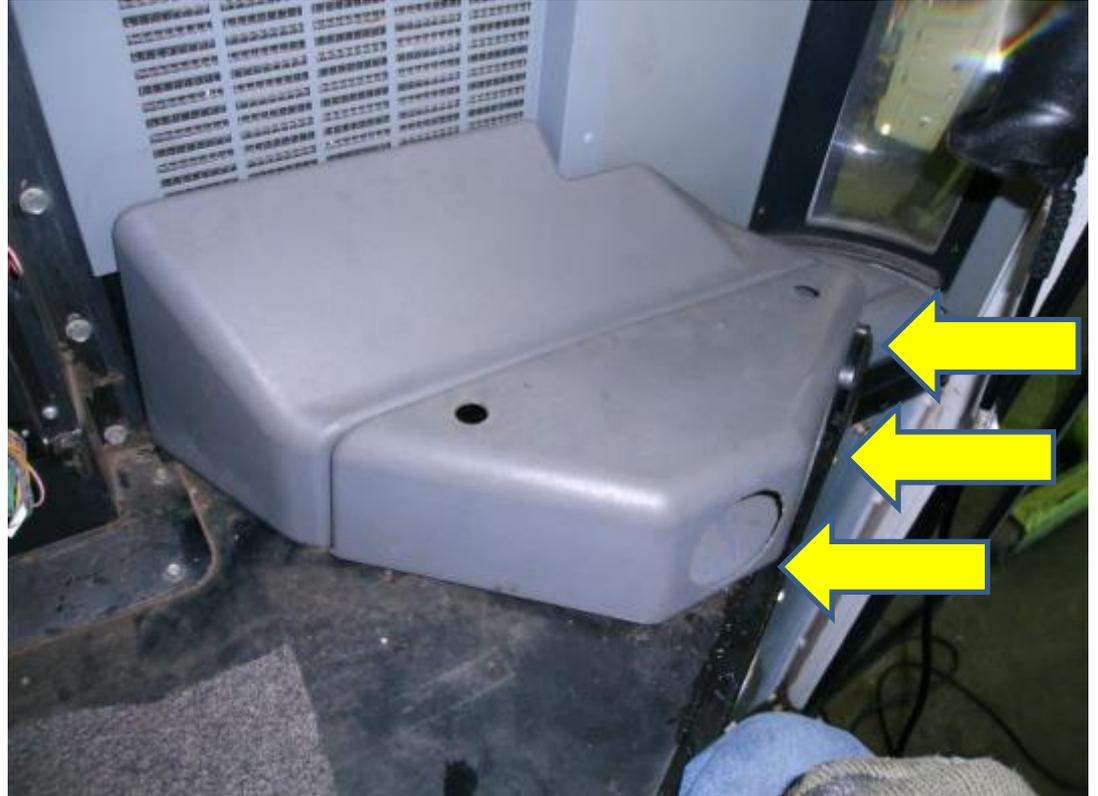
Remove the air deflectors  
on the side of the unit

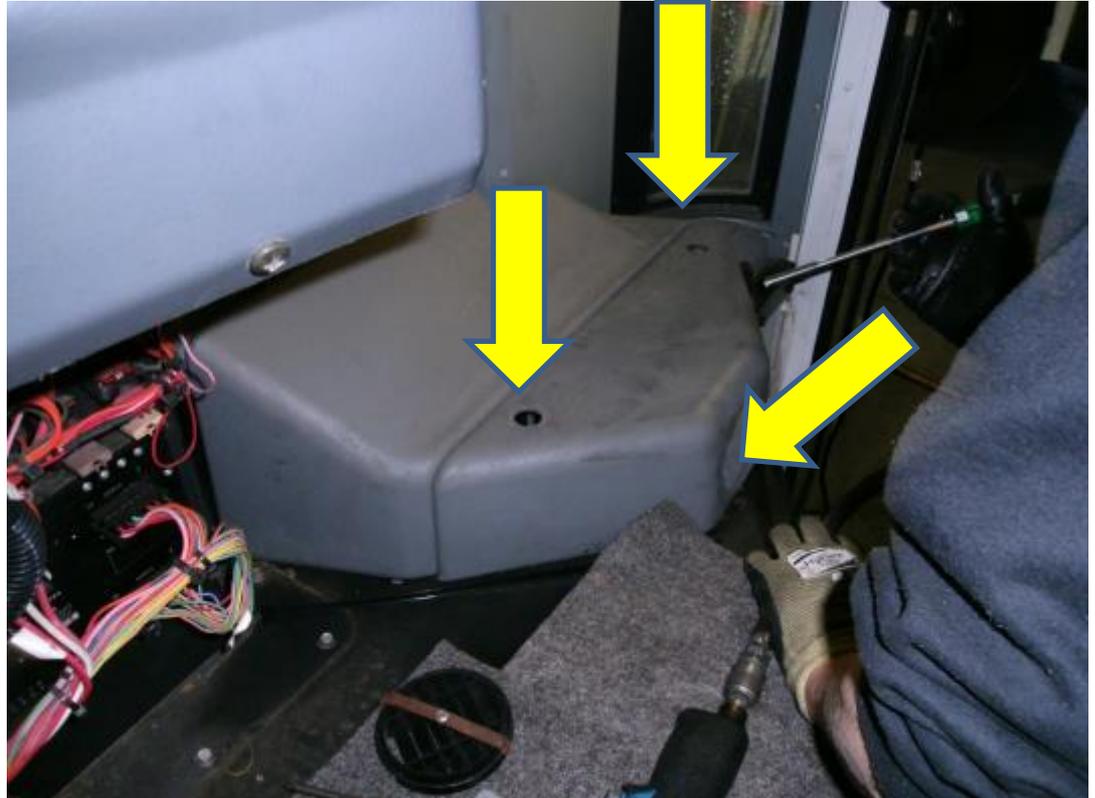
Remove the screws that  
are holding the duct in  
position

The screw locations are  
inside of the air duct

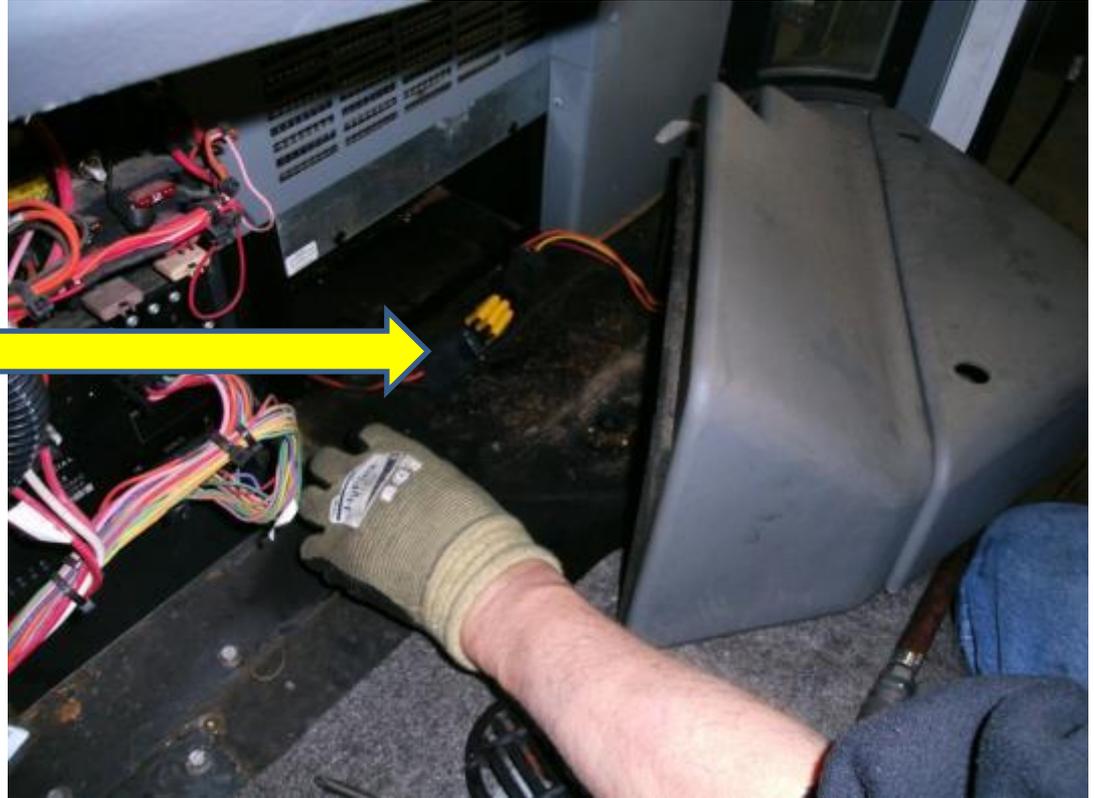
Slide unit back from front of vehicle

Install jumper harness

Bergstrom part #1000662031

orange wire – 20A fuse

red wire – 7.5A fuse

yellow wire – 5A fuse

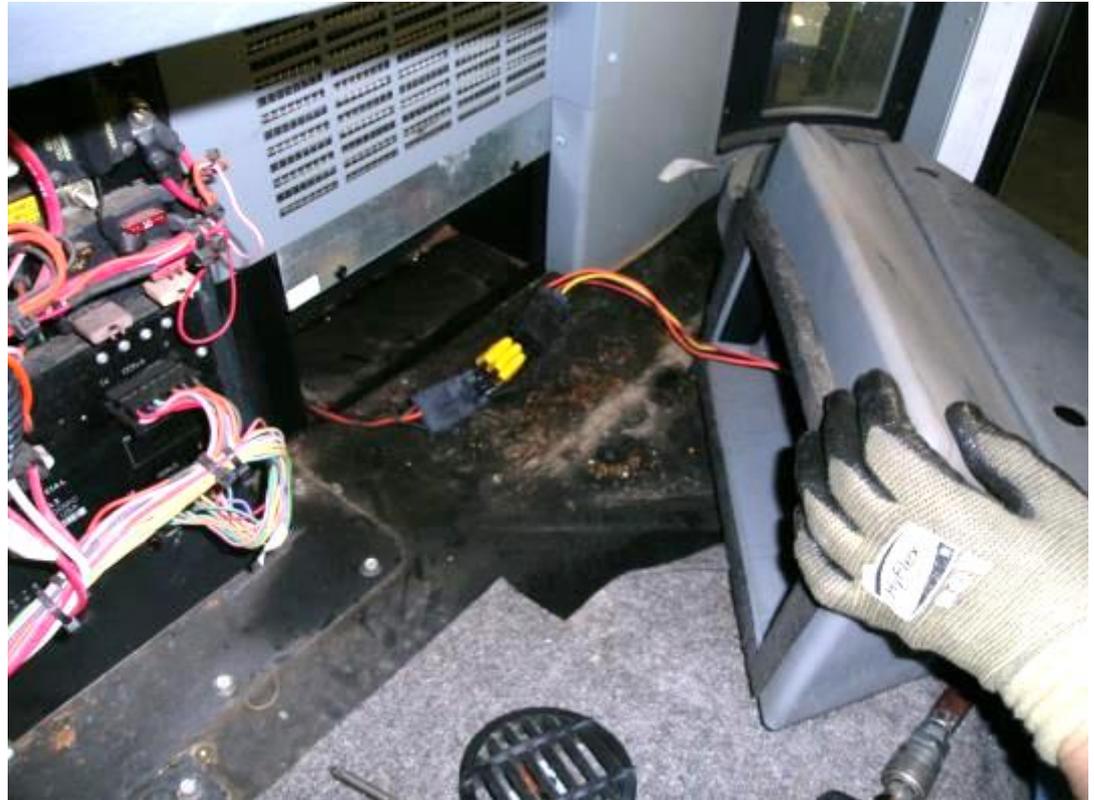
Run the blower on **HIGH**  
for 2 minutes

Run the blower on **LOW**  
for 1 minute

If the blower keeps  
running in both speed  
ranges, reinstall unit

If either fuse blows,  
replace the blower motor  
assembly
